Manhole Inspection Summary

Manhole # S13EE_015MH

Insp Date: **2/26/08 10:15 AM**

Location Address: **REAR OF 1318 BLOOMINGDALE RD** Cross Street: **BELMONT AVE**

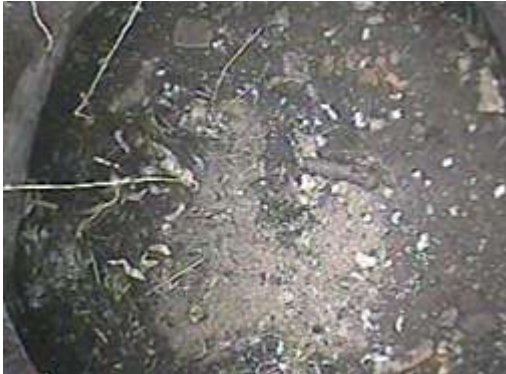
Defect 1

Condition: ☐ Sound ☐ Cracked ☐ Root Intrusion ☐ Deteriorated ☐ Leaks ☒ **Debris**

DEBRIS

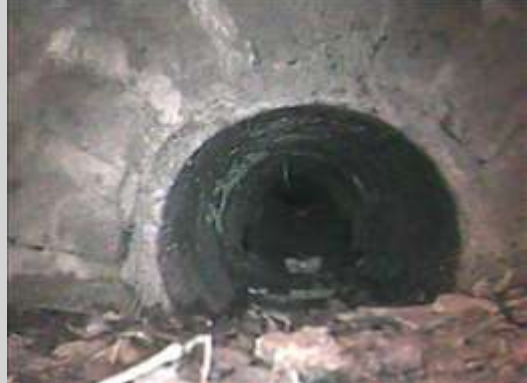
12 O'Clock Outflow

6 in. Circular Gravity Sewer
Pipe Out @ 12 O'Clock

Deposits: ☐ None ☐ Mud ☐ Sludge ☒ **Debris** ☐ Grease

Silt Depth: **1** (in.) Deposits Extent: **Light**
